SUBJECT: Clutch Yoke 40-781 in
LA-5 and LA-6 machines.

DATE: July 25, 1934

We release herewith a four plate Bulletin covering the adjustments of the 40-781 and its related mechanism. Conditions resulting from improper adjustment of these parts, are listed in the order of their most frequent occurrence together with the proper methods of correcting and testing.

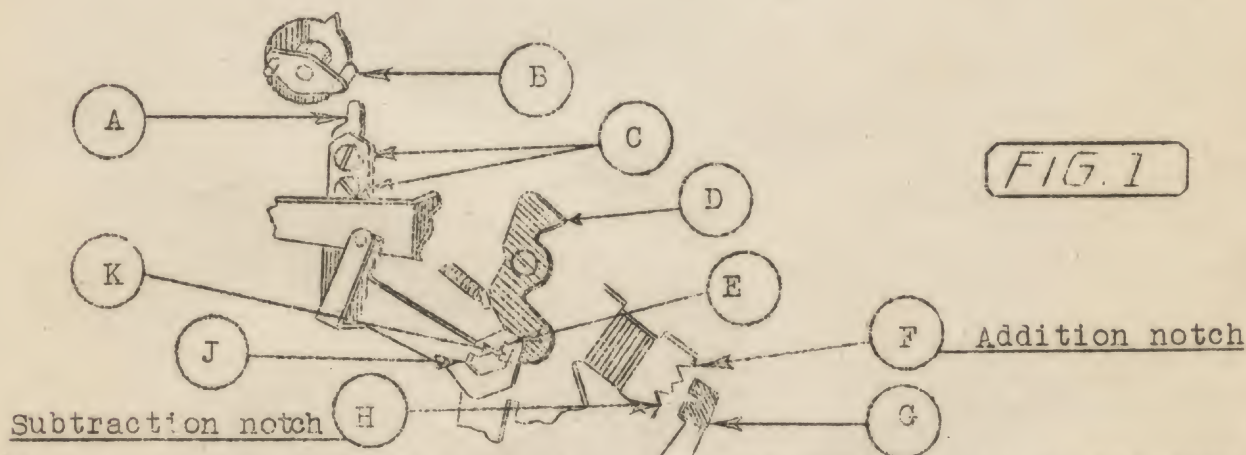
Continuous Running of Machine in Addition or Subtraction

This rocking motion is caused by the failure of offset (K) to unlatch from position (J) before the clutch yoke click enters the addition notch in the clutch yoke, thereby causing the 4708 blank (A) to continue in the path of the 4757 stud (B) on the crank arm. As the cycle stopping arm returns to the bumper pad after the final tripping of the trip lever the clutch yoke fails to neutralize due to the 4757 stud (B) engaging the 4708 blank (A) and causing the clutch yoke click (G) to seat in either the addition (F) or subtraction (H) notch in the yoke resulting in the machine running continuously.

To overcome this condition adjust the 4708 blank (A) to the 4757 (B) stud by loosening screws (C) and positioning blank (A) upward, downward, forward or rearward to suit in relation to stud (B) as follows.

- 1 When offset (K) is positioned at (E) and the clutch yoke click engages either of the three notches "add, subtract or neutral," the stud (B) should not engage the 4708 blank (A)
- 2 When offset (K) is located in position (J) and the clutch yoke click (G) is in the neutral notch of the clutch yoke, stud 4757 (B) should strike the rear of blank 4708 (A) with sufficient force to position the clutch yoke click (G) in the subtraction notch (H). When click (G) is in neutral, stud (B) should strike blank (A) and cause the clutch yoke click (G) to move into the addition notch (F). When (K) is in position (J), and (G) is in either of notches (F) or (H), stud (B) should not engage (A).

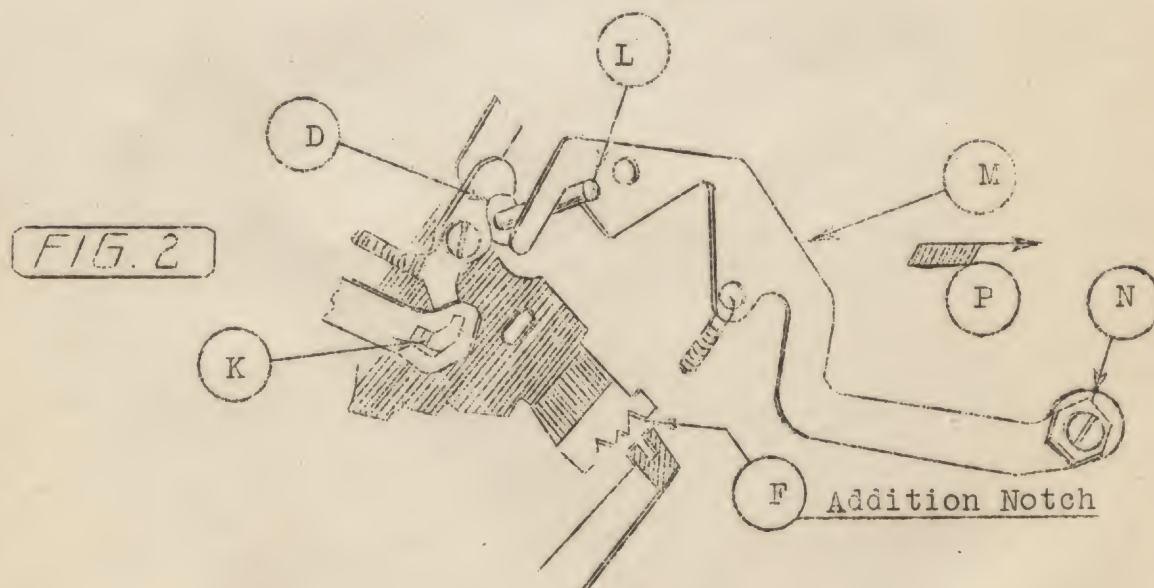
"Nines" Remaining in Lower Dials

This condition is caused by offset (K) unlatching too quickly, thereby causing the clutch yoke to neutralize instead of the clutch yoke click entering the addition notch thereby allowing the mechanism to make an addition cycle which would clear out the "nines."

This condition may be remedied by adjusting the division lever click (M) in direction of arrow (P) by means of eccentric nut (N) thereby increasing the clearance between the latch (D) and stud (L).
